# Rehabilitation of Mechanics Hall

Matthew J. Cogswell  
*Worcester Polytechnic Institute*

Mechanics Hall is an historic building built in 1852 in Princeton, Massachusetts. The project goal was to develop a plan to bring Mechanics Hall into compliance with current building code requirements. A field inspection was performed to gather data used to develop a Building Information Model. Due to the extensive use of building code, a Code Review was developed, along with a design and cost estimate for two proposed uses. The results were presented to the Friends of Mechanics Hall.

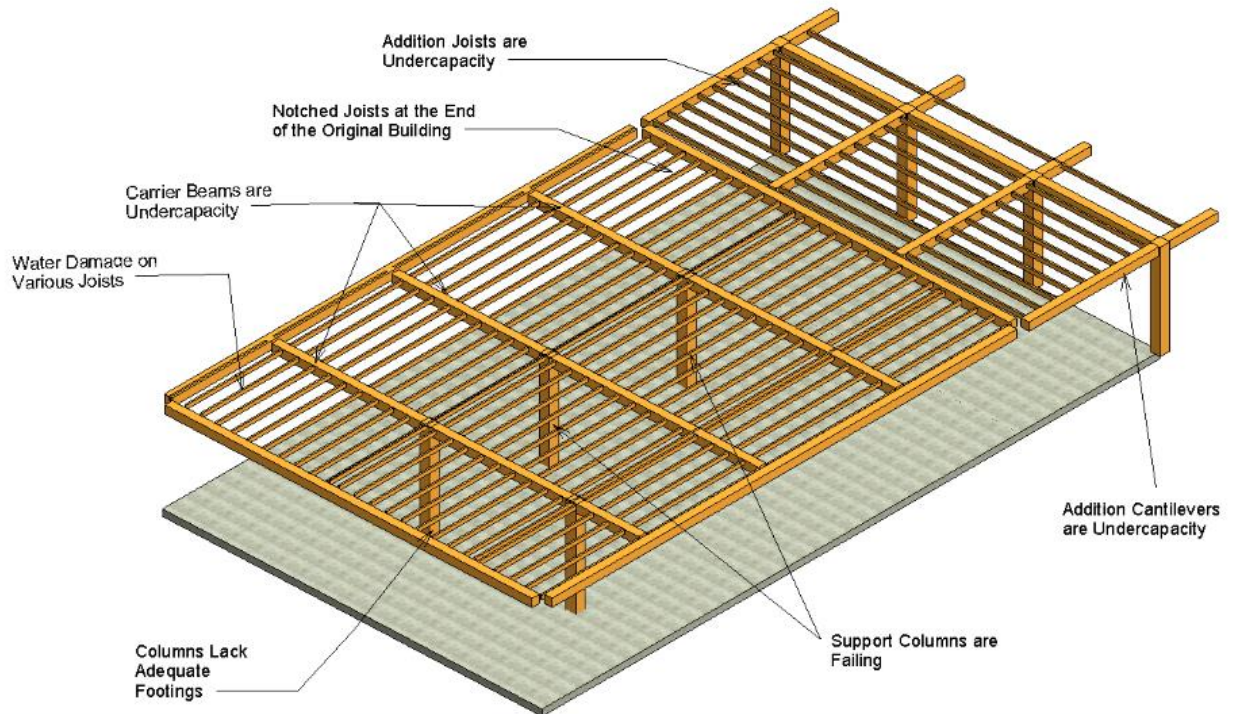
Figure 11: Mechanics Hall Frame Damages

The entire addition except for the floor decking and the columns will need strengthening to support the required loads. The joists in the addition span a longer length than the joists in the main building, which causes enough additional stress to render the joists inadequate to handle the required bending stress. The cantilevered carrier beams require reinforcement for bending and shear. The loading on the internal span of the carrier beam is so great that the cantilevered section of the beam is pushed upward rather than downward. This creates the perception that the cantilevered section can support greater loads with a lower deflection. The areas of concern for the entire Mechanics Hall frame can be seen in Figure 11.

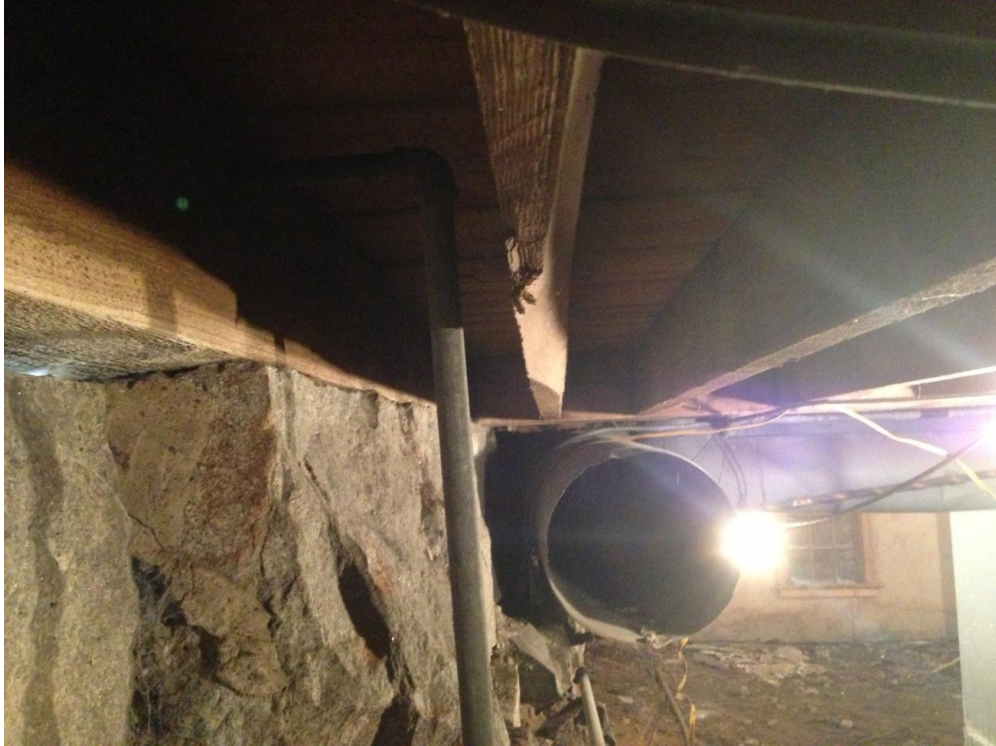
Figure 14: Warped, cut joist in between Carrier Beams A & B - Side View.

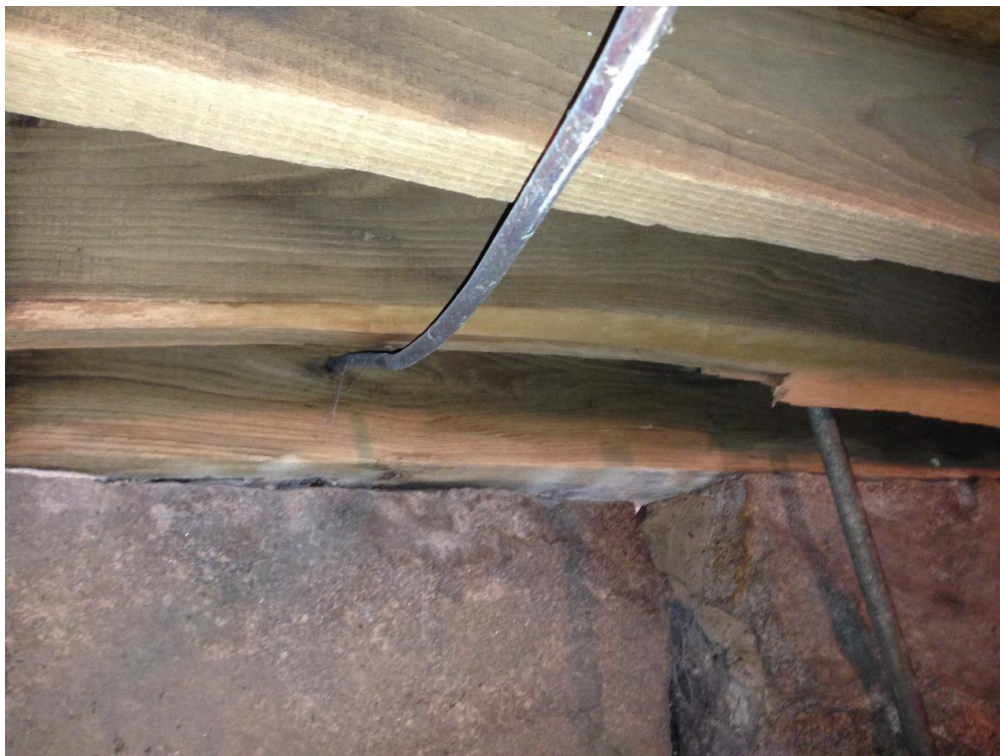
Figure 15: Warped, cut joists between Carrier Beam A and B - Front View

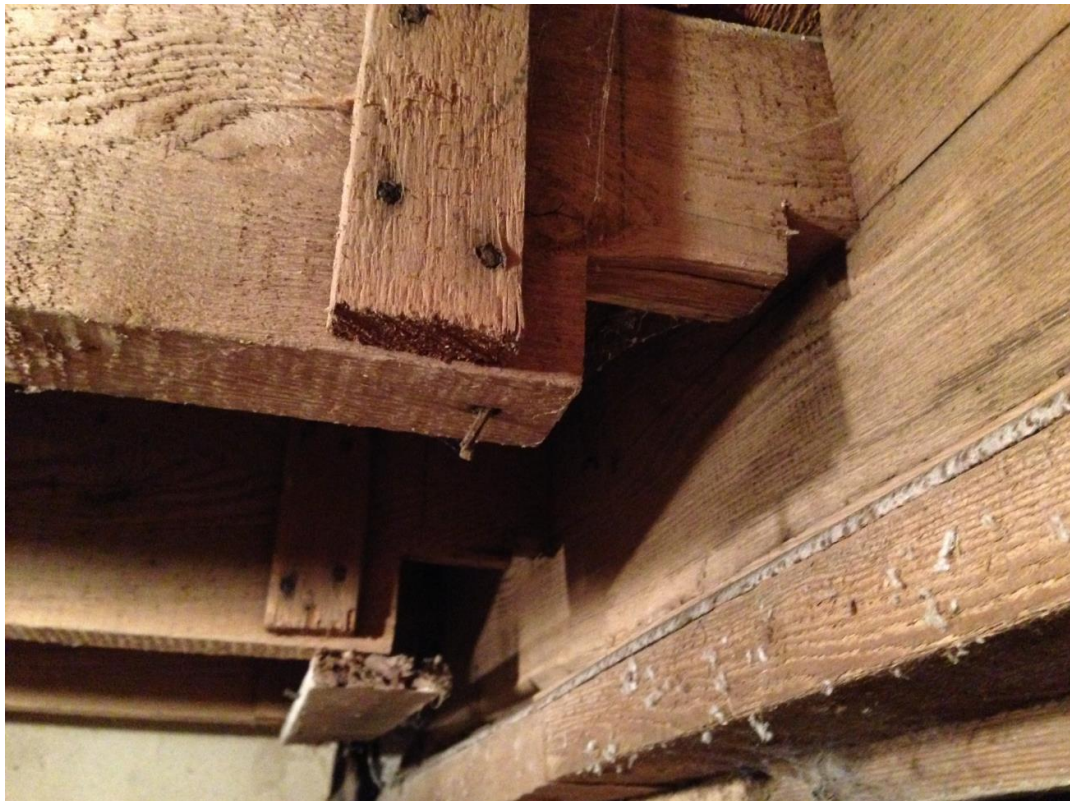
Every beam in the North bay between the North Carrier Beam to the addition has notches at the end of the span. As seen in Table 11, these beams fail the shear check due to the missing material. The notches in these beams also do not meet the standards specified in NDS Section 4.4.3. The standards specify that the notch may not be greater than  $\frac{1}{4}$  of the depth of the beam, whereas the notch in the beam is close to half the depth, as seen in Figure 16. The Middle Column is splitting down the middle, and all columns show signs of insect damage (Figure 17). The footings for the columns consist of rocks with no concrete or grout, as the floor of the basement is dirt (Figure 18).

Figure 16: Crossbeams notched at the end of the spawn at the back end of the Main Building.

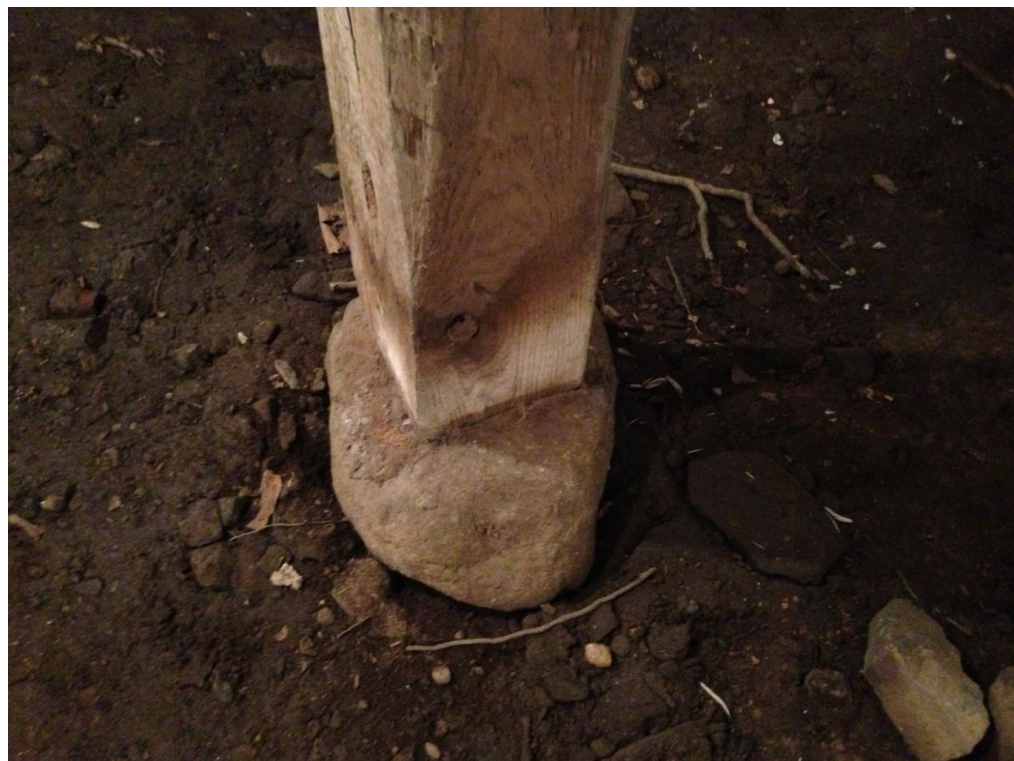
Figure 18: Rock footing for support column in the basement.

The new columns will require new footings to adequately disperse the load to the earth. The existing footings are insufficient for this purpose. The new columns should be made of reinforced concrete. In accordance with IBC 1809.4, the base of the footing must sit a minimum of 12 inches below the existing grade. For Mechanics Hall, this minimum will suffice. The footing should be a square 36" x 36" x 12" deep centered beneath the column. Due to the minimum required reinforcement needed, No. 7 rebar must be placed at a depth of 9" running in both directions to form a grid, as depicted above in Figure 31. The rebar should be spaced every 5" on center, with no rebar placed within 3" of any edge of the footing. This is shown below in Figure 32, with the red dotted lines indicated the placement of the reinforcing rebar. The supporting calculations for the column and the footings can be found in Appendix D and E respectively.

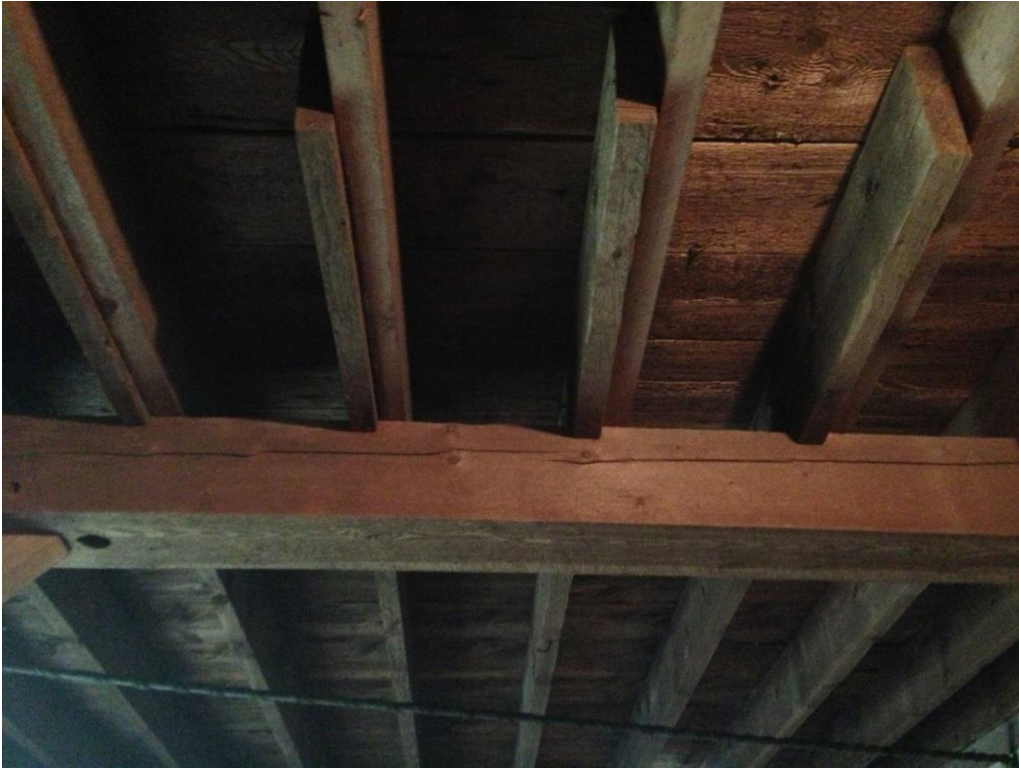
The structural members of the addition are generally less damaged than the members found in the original building. As seen in Figure 19, the main structural frame is free from mold and other visual signs of decay. Occasional cracks were found in structural members, as seen in Figure 19. The majority of the damage in the addition is found in the sideboards that make up the wall. These boards are exposed directly to the earth beneath the wall, resulting in rot and decay in the walls. Figure 20 depicts a hole that has rotted through on the side of Mechanics Hall. There is no foundation underneath the addition.

Figure 19: Framing as seen from the basement of the Addition

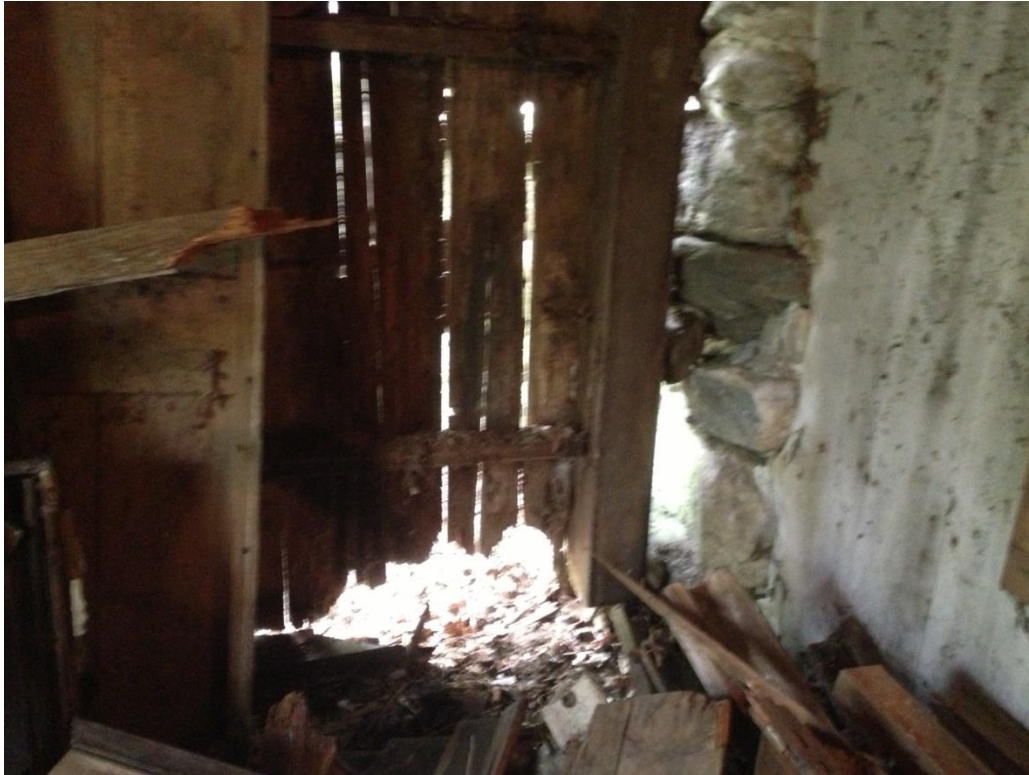
Figure 20: Hole in exterior wall as seen from the Addition Basement.

The addition has no foundation walls, as the land surrounding Mechanics Hall slopes downwards towards the back. The wooden exterior walls of the structure are in direct contact with the ground. This has led to significant rot and moisture damage in the exterior wall of the building, as depicted in Figure 20.
